# Manhole Inspection Summary

Manhole # S35UU\_002MH

**Location** Address: **2817 CALVERT ST**

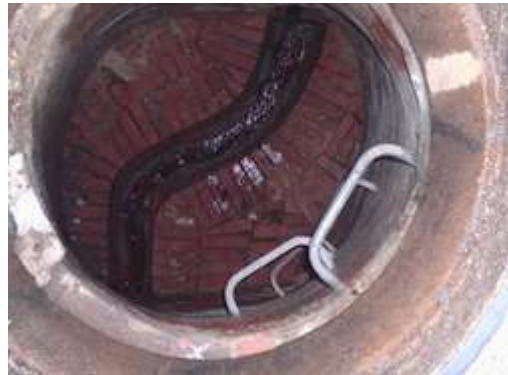
Top View

Bench debris.

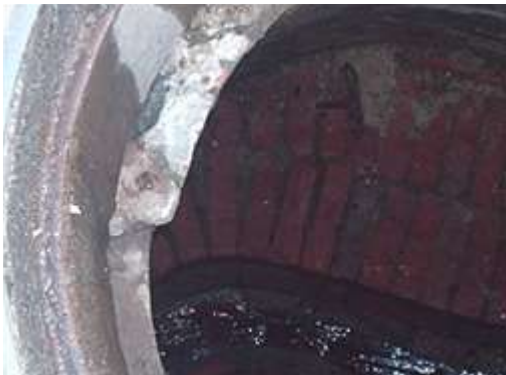
Defect

Condition: ☐ Sound ☐ Cracked ☒ **Leaks**

Condition: ☐ Sound ☐ Cracked ☐ Root Intrusion ☐ Loose Brick ☒ **Deteriorated**

Infiltration: ☐ None ☒ **Joint** ☐ Cracks ☐ Mortar ☐ Roots ☒ **Wall**

Frame leaks. Frame offset. Adjustment deterioration and infiltration.

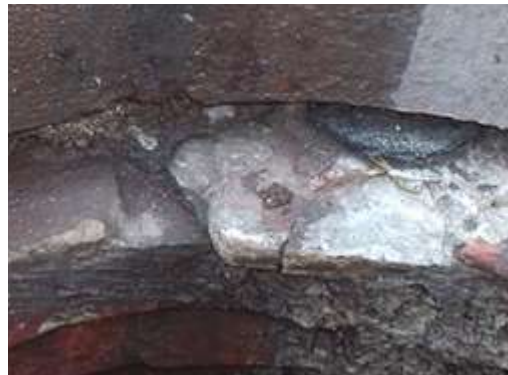
Defect

Frame leaks. Frame offset. Adjustment deterioration and infiltration.

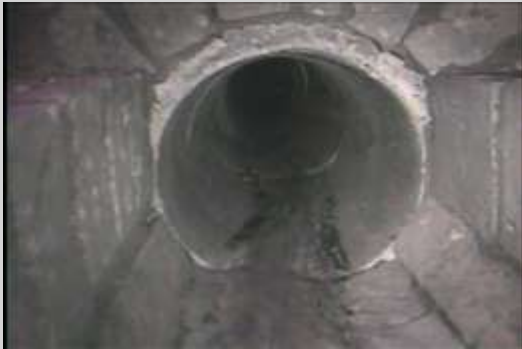
### 8 in. Circular Gravity Sewer Pipe Out @ 12 O'Clock

Infiltration: **Evidence** Pipe Seal Cond: **Unknown**

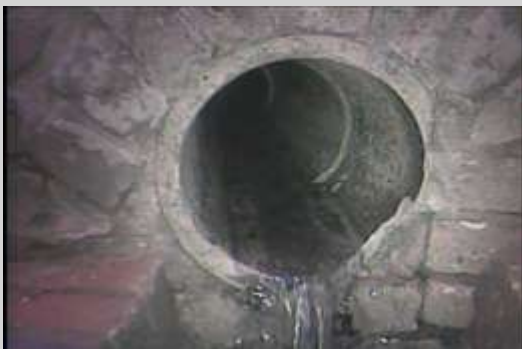
### 8 in. Circular Gravity Sewer Pipe In @ 6 O'Clock

Infiltration: **None** Pipe Seal Cond: **Broken**
